DrayTek Product Safety Advisory

Priority : Urgent / Immediate
Release Date : 18th July 2006
PSU No. 3A-181WP15

For all Vigor2800 Series Users

Issue 2 : Updated 7th August. UK Only.
Also available at www.draytek.co.uk/psu

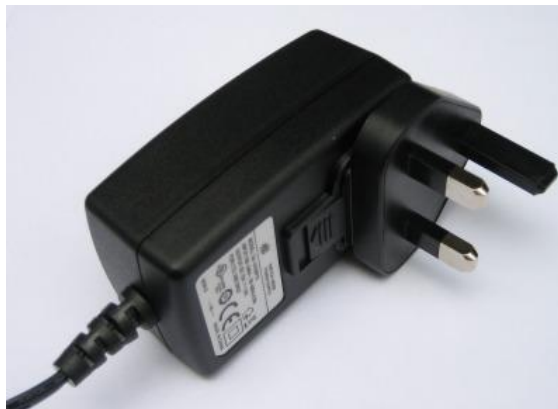
A potential safety issue has arisen with one of the PSU types used by DrayTek. The PSU concerned consists of two parts; the main PSU body and a UK-specific 3-pin plug plate. These two main parts are intended to and can be detached safely (in order that pins for other geographic areas can be attached instead).

The PSU concerned is labelled as model No. 3A-181WP15. It is a mains Power Adaptor which has been supplied with Vigor2800 Series Routers. Please refer to photographs later in this document to aid with identification of the product and specific components.

All users should immediately check their PSU. Remove the PSU from the mains socket, having firstly isolated the mains supply (turn off the socket switch). Whilst holding the main body in one hand, confirm that the plate part cannot be pulled apart with reasonable force with your other hand (tug and push the pins and plate in all directions). In the reported incident, minimal force was required. Do not use excessive force or use any tools. If unsure, seek further advice from us. If the PSU appears sound, you can resume normal usage of it, however **please do still email us** in order that we have your details on file should there be any further information that we need to send you on this issue.

DrayTek will send you a replacement PSU; you should retain the broken part safely in case we require it back for examination. Please do not attempt repair or modification.

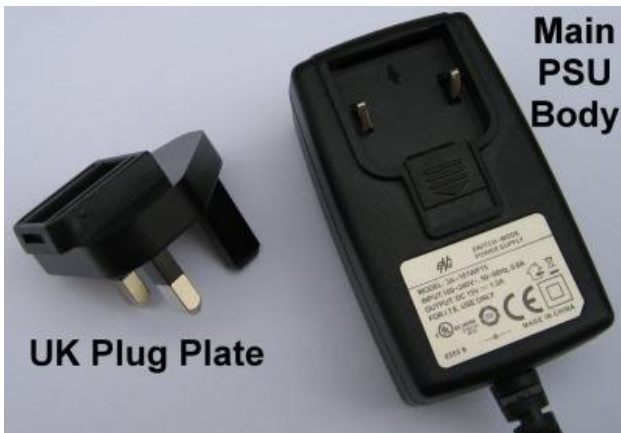
UK Plug Plate

Note that the problem is not the plate coming away from the main PSU body, which is locked by the sprung latch, but the plate component itself coming apart. There will always be slight movement between the plate and the main PSU body but the plate itself should be fixed firmly. Please examine the photos below to see specifically.

Component Parts

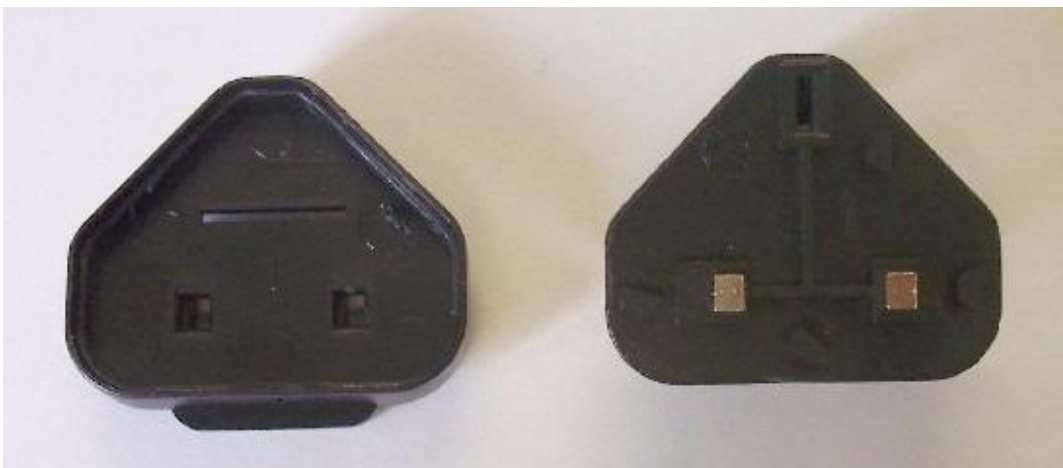
A report has been received in which the plug plate has come apart which would expose live metal if the plug remained in the wall socket and the socket switch had been left on. This could present a risk of electric shock to a user who has not noticed the problem.

The failed/detached plug plate
